Information Paper

Lessons from AIMC4 for cost-effective fabric-first low-energy housing

Part 5: As-built performance and Post Occupancy Evaluation

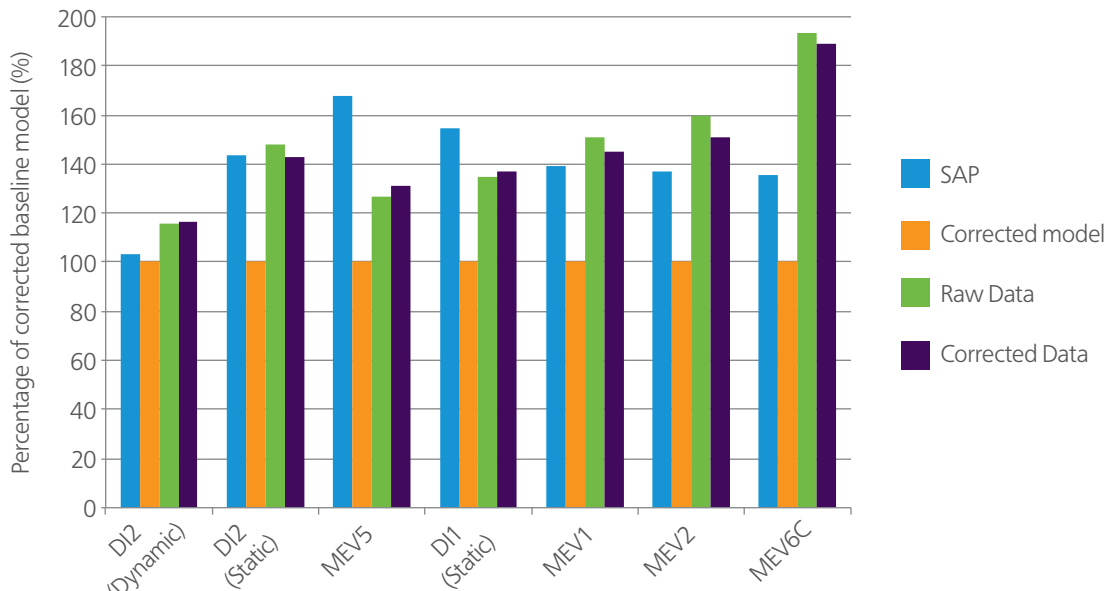
Figure 2: Co-heating tests results showing the heat loss relative to the corrected baseline model

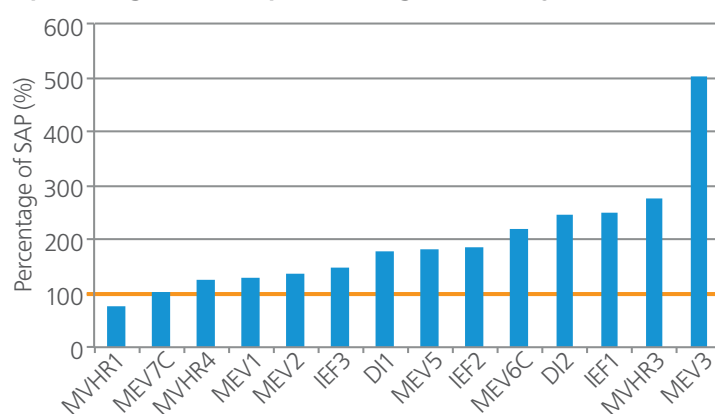
Figure 3: Measured Space Heating Sent to Radiators as a percentage of Gross Space Heating Predicted by SAP

in-use performance is over twice that predicted by SAP. This is indicative of some underlying mismatch between the heat loss result calculated by SAP and the performance of the fabric of the dwelling, which is being picked up by the co-heating test and potentially confirmed by the in-use measurement.

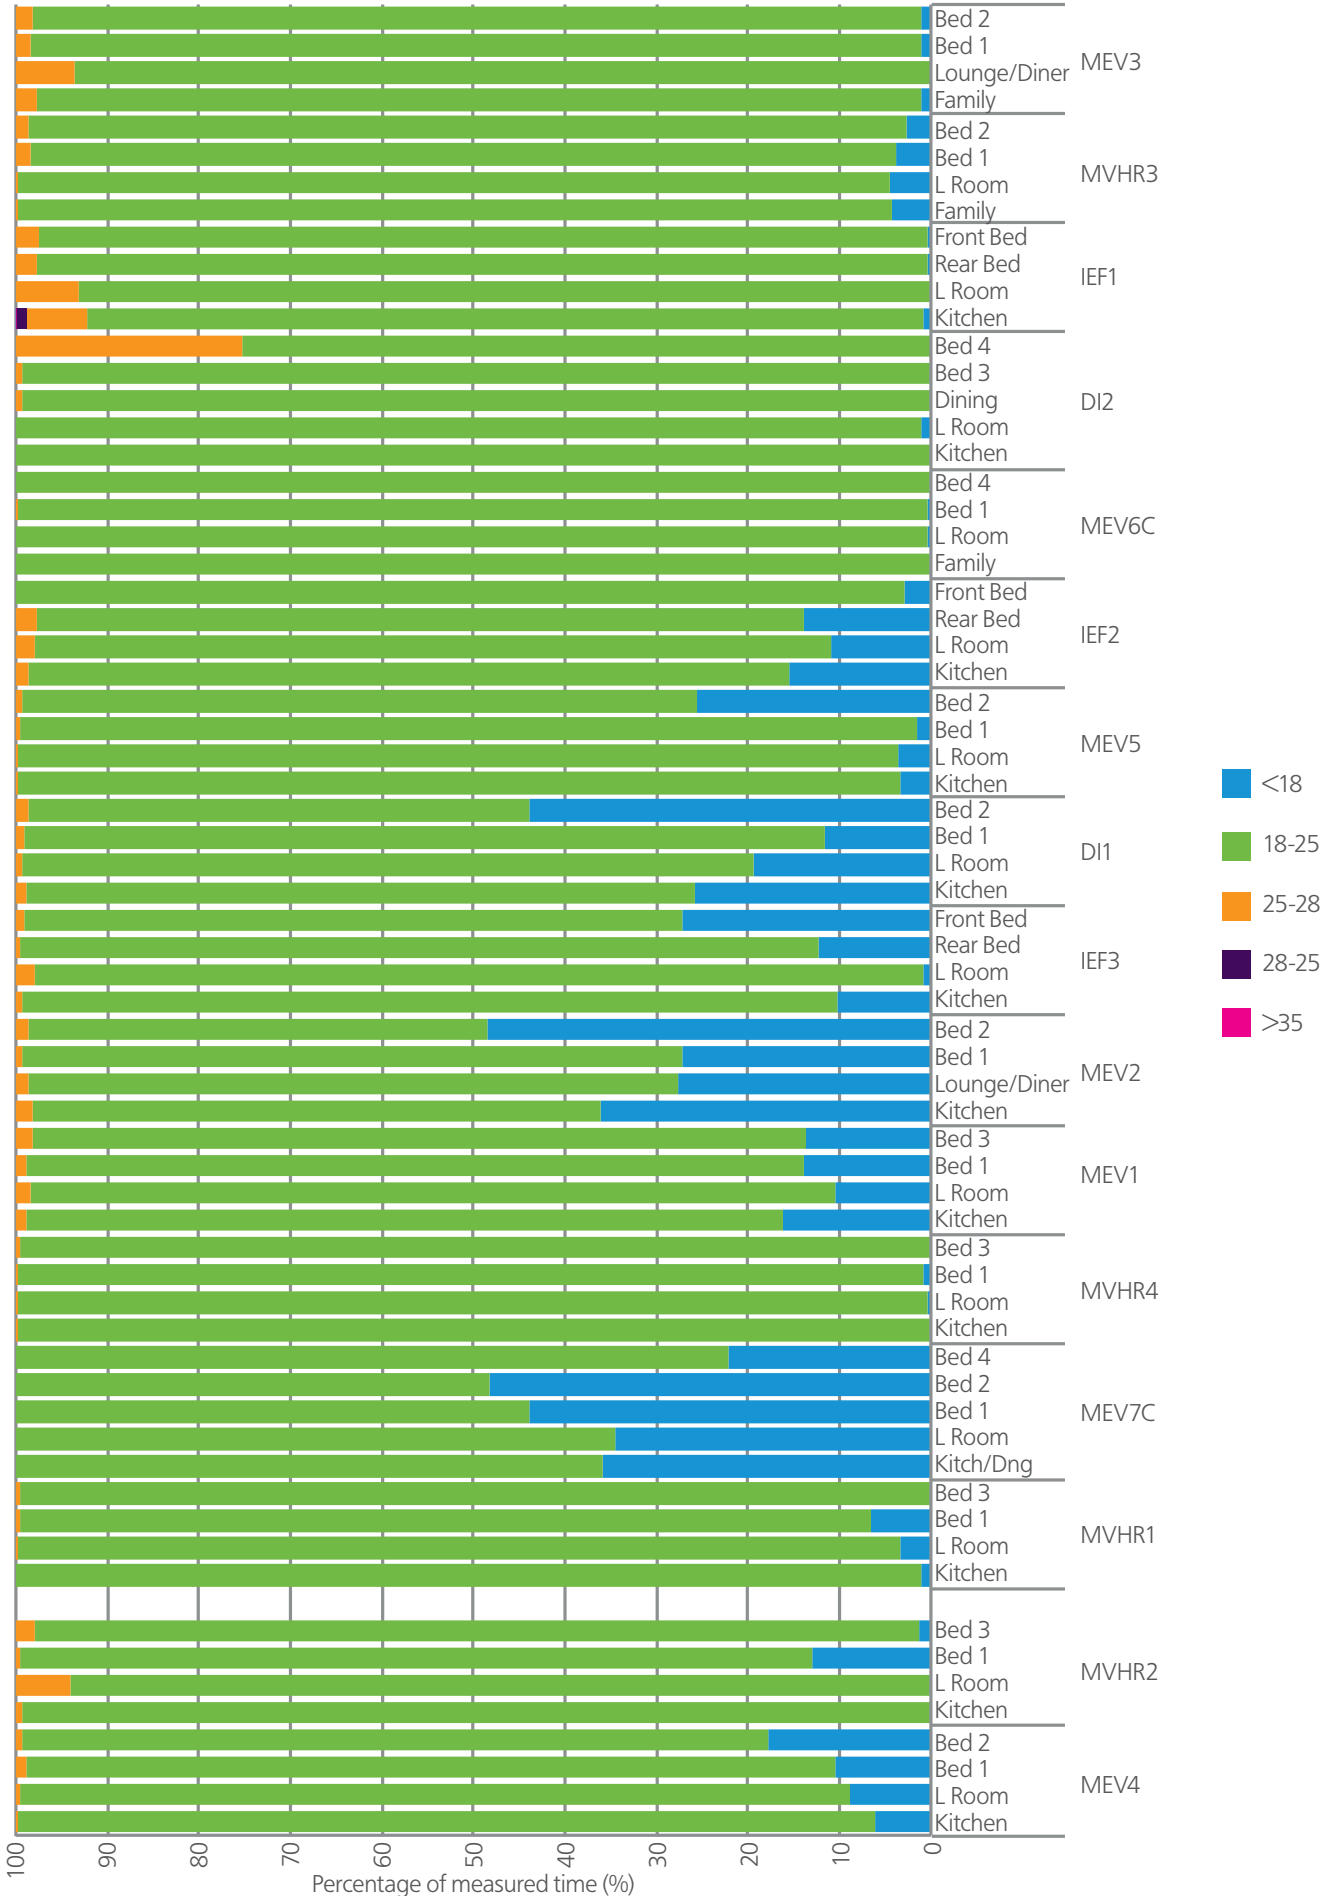
Figure 4: Percentage of measured time that the homes are within the temperature ranges
 (note that no temperature data was collected in Homes MEV7C and MVHR1-4 in July and August).

One of the key pointers to how the homes are being used is the temperature in which they are being operated. This can be seen in Figure 4 (shown over) which shows the proportion of time that the temperatures of different rooms in the dwellings are within certain bands⁸. With the exception of the two houses on the bottom of the chart they are in the same order as Figure 3; i.e. the ones on the bottom of the chart use proportionally more space heating energy than the ones at the top. In the case of the two houses at the very bottom, no space heating data is available due to an equipment failure.

It also appears to be the case that homes MVHR1, 3 and 4 tend not to cool down below 18°C. This is not a thermal mass effect, as these homes have a relatively low thermal mass. It is therefore likely that this is a combination of the relatively good airtightness (preventing outside infiltration of cold air), the fact that all three keep their windows closed during the winter (0.1-0.3% of the time between November and April) and that the MVHR systems are recycling space heating and heat gained from showering and bathing activities. Home MVHR2 behaves differently with bedroom 1 in particular cooling down, but the windows in this house are open 1.8% of the time between November and April. The loss of temperature data for July and August for these houses, due to a technical fault, prevents any analysis of what is happening at the other end of the temperature scale and skews the temperature results for these properties.

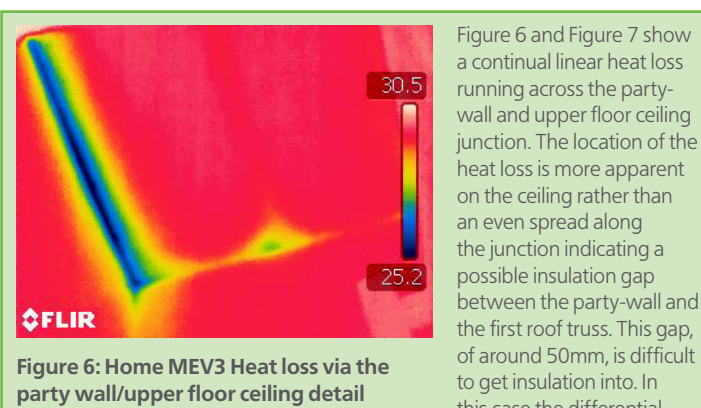
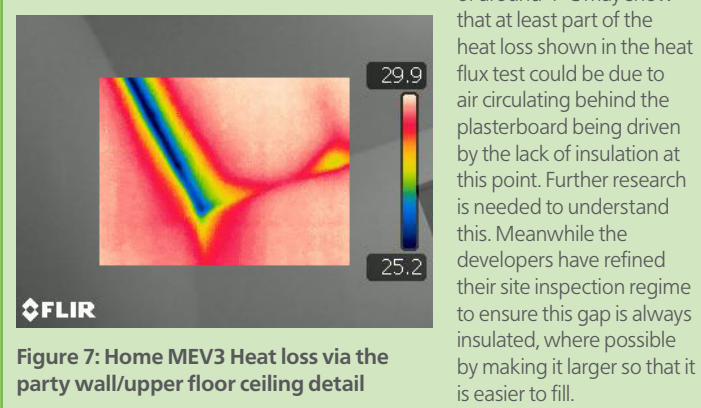
Figure 6: Home MEV3 Heat loss via the party wall/upper floor ceiling detail

Figure 6 and Figure 7 show a continual linear heat loss running across the party-wall and upper floor ceiling junction. The location of the heat loss is more apparent on the ceiling rather than an even spread along the junction indicating a possible insulation gap between the party-wall and the first roof truss. This gap, of around 50mm, is difficult to get insulation into. In this case the differential of around 4°C may show that at least part of the heat loss shown in the heat flux test could be due to air circulating behind the plasterboard being driven by the lack of insulation at this point. Further research is needed to understand this. Meanwhile the developers have refined their site inspection regime to ensure this gap is always insulated, where possible by making it larger so that it is easier to fill.

Figure 7: Home MEV3 Heat loss via the party wall/upper floor ceiling detail

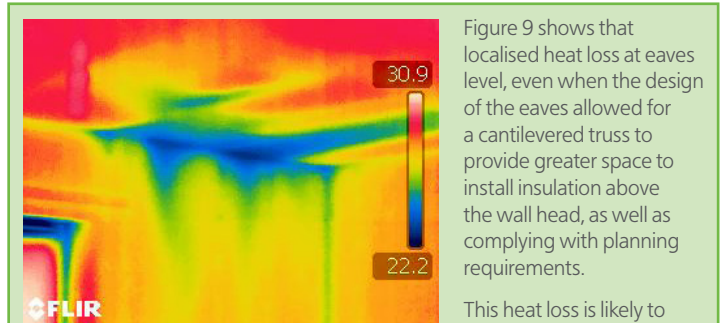
Figure 9: Front bedroom external wall / ceiling junction

Figure 9 shows that localised heat loss at eaves level, even when the design of the eaves allowed for a cantilevered truss to provide greater space to install insulation above the wall head, as well as complying with planning requirements.

This heat loss is likely to be caused by either the solid timber header beam or air movement around the eaves area (where loft insulation does not always reach the eaves point).

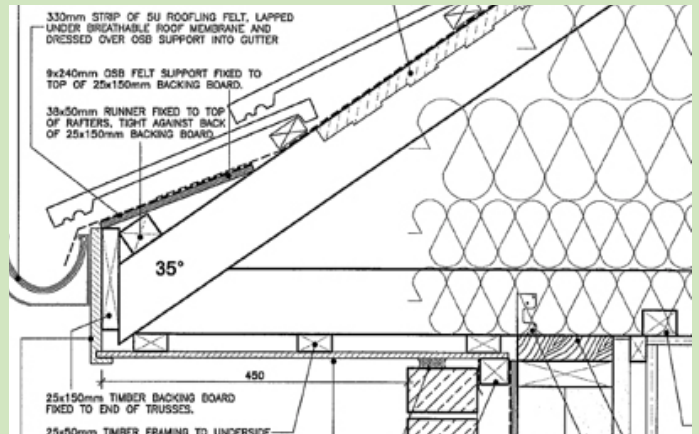
Figure 10: Eaves design detail

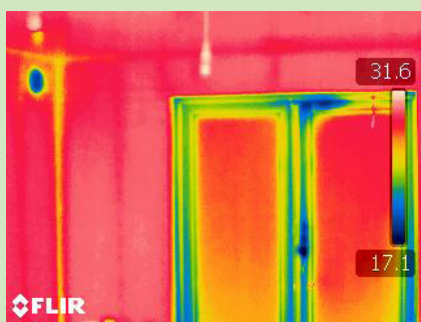
Figure 11: Living room dynamic insulation supply louvre in external wall and heat loss around French doors

Figure 11 shows two issues. The first is the incoming air from the dynamic insulation louvre. The photo has been taken during the co-heating test and the louvre is bringing in air at around 21°C, but the walls are at around 30°C (which does not reflect in use conditions).

The second issue is the poor seal around the French doors. These may have been installed out of square, but it is more likely that they have dropped or twisted through their own weight, as they are triple glazed. This issue was seen in some other large windows on a mixture of AIMC4 sites.

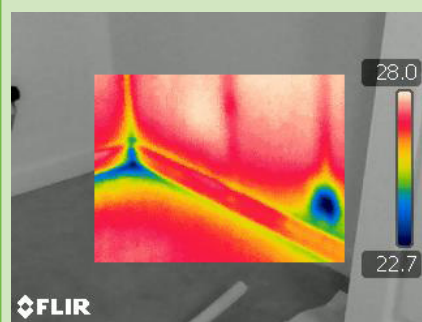
Figure 12: Cold spot on external wall

Figure 12 shows a cold spot within the dining room. Behind this, there is a recessed external gas meter housing which requires a penetration through the external closed panel wall.

Although the detail shows external sealant and insulation, it is possible that one or the other (or both) has not been followed. This has resulted in a localised thermal weak spot (or air movement) around the conduit penetration.

As a result of identifying this problem changes have been made to the developers quality assurance procedures.

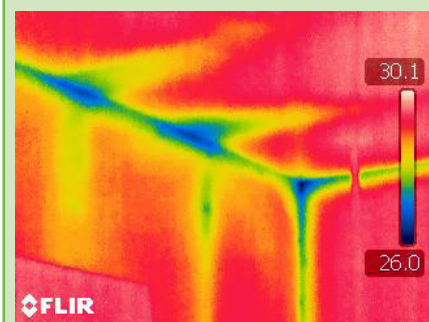
Figure 13: Heat loss from guest bedroom adjacent gable wall

Figure 13 indicates heat loss within the ceiling below the roof space. The cold areas suggest possible ingress of cold air beneath loft insulation. This is likely to be as a result from the complexity of fitting ceiling insulation in this area.

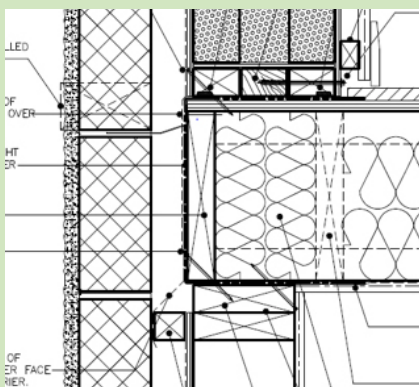
Figure 15: Construction details

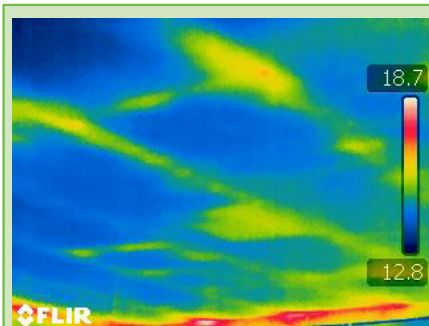
Figure 16: Heat loss through integral garage ceiling.

Figure 16 shows heat losses from the living space above the integral garage, through the floor zone. The floor contains a complex arrangement of plumbing works relating to hot water and heating feeding the en-suite above and rising from the boiler located in the garage (see Figure 17). This resulted in hard to insulate areas within the floor zone.

The thermal bridges from the ducts are also not accounted for in SAP.

This analysis has resulted in consideration being given to changing both insulation design and site quality assurance practices associated with integral garage homes.

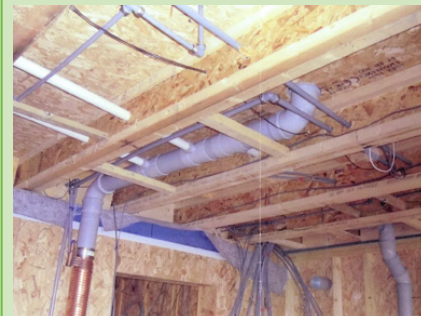
Figure 17: Integral garage ceiling during second fix

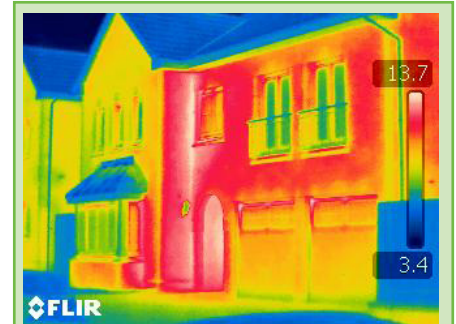
Figure 18: Heat loss around front door entrance

Figure 18 shows the entrance recess, which is approximately 900mm deep with relatively slender returns to work in and with internal partition layouts and external coursing. As a consequence, the corner arrangements have a higher than normal amount of timber studs. The floor above extends over the top and is supported on an arrangement of timber joists within the floor zone. This is further complicated by the inclusion of stairwell trimmers from the stair void opposite the entrance. As a consequence there are many timbers, resulting in a hard to insulate area and increased levels of thermal bridging.

A similar problem is occurring at the inverted corner of the bay window.

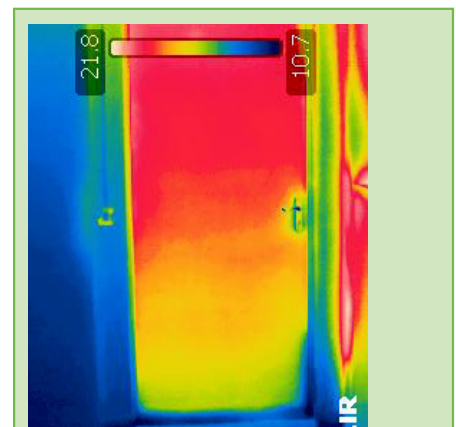
Figure 19: Heat loss via internal access door to integral garage

Figure 19 indicates strong temperature contrasts covering quite a large area suggesting significant heat loss. The integral door between the garage and utility room is an un-insulated solid core internal fire door. The U-value of the fire door is 2.0. This is not a design versus as-built performance issue as this was known at the design stage and accounted for in the SAP model. The utility space helps buffer the heat loss and forms a sheltered space, between the kitchen and garage, which is infrequently occupied.

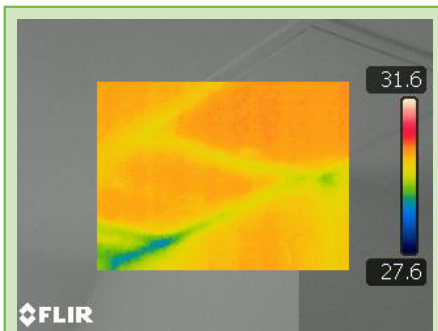
Figure 20: Loft hatch

Figure 20 shows a very well insulated loft hatch opening. The insulation goes all the way to the opening and the seal is good. This was not the case in all AIMC4 homes and through this work new hatches have been sought that provide an improved seal.

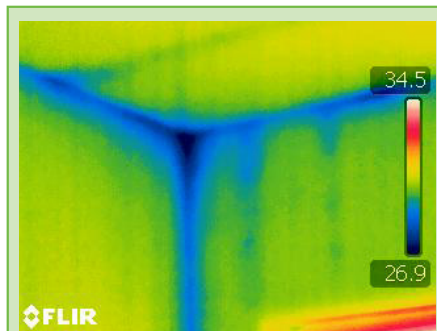
Figure 21: showing slight cold spots along the

- (i) party wall / second storey ceiling junction (to the top left of the image) and**
- (ii) front elevation external wall and second storey ceiling junction (to the top right of the image)**

Figure 21 shows only around a 1°C difference in temperature at the interface with the party wall and ceiling junction.

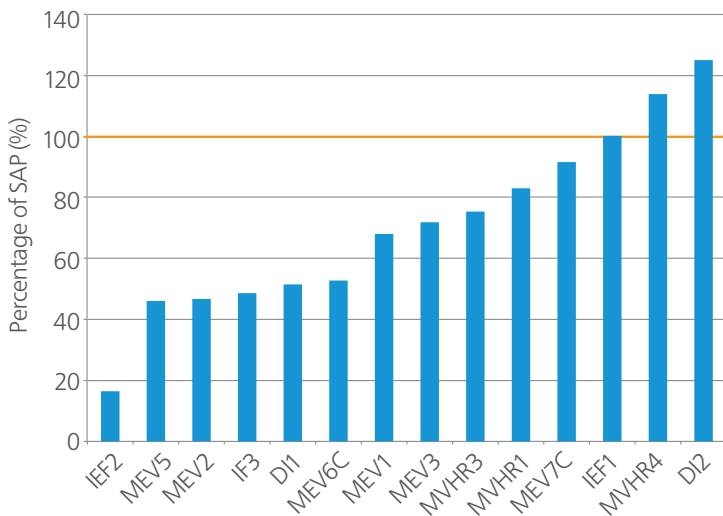
Figure 22: Measured Water Heating (normalised) as a percentage of Gross Domestic Hot Water Shown in SAP

With the exception of three homes all the properties used less heat for hot water than would be expected from SAP.

As with space heating, it is not possible to measure directly the water heating shown in SAP. What has been measured is either net heat to the hot water cylinder, net heat from the domestic hot water system output (where there is no cylinder) or in the case of one house where a fuel cell was used, net heat from the thermal store output. These measurements have been normalised to compare them with SAP by dividing by the number of people actually in the house and multiplying by the number of occupants used in SAP (which assumes a direct linear relationship between the number of occupants and the hot water use). The results when compared to the SAP prediction are shown in Figure 22⁹.

If the total water consumption is divided by the number of occupants per house in the SAP model, this produces Figure 23¹⁰. By comparing Figure 22 and Figure 23 it is possible to see that there are some links: The three largest users of energy for hot water, homes DI2, MVHR4 and IEF1 are amongst the four biggest users of water. Home IEF3 had excessive water use due to a water leak external to the property which took some time to resolve. The lowest user of energy for hot water, home IEF2 is also the lowest user of water.

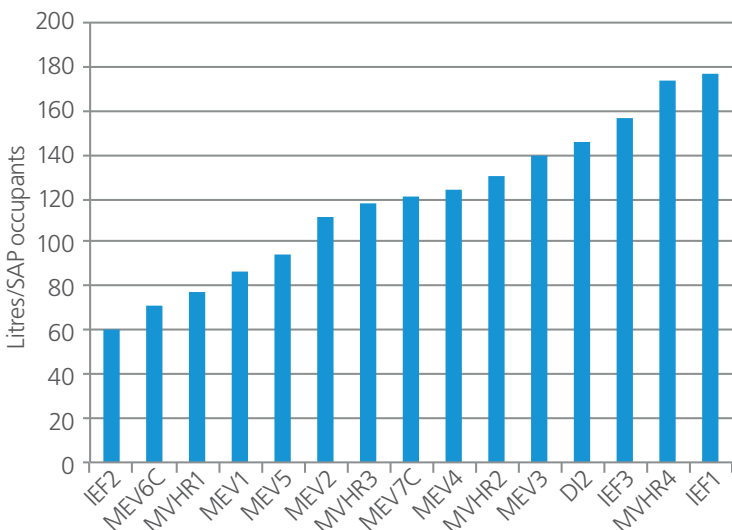
Figure 23: Water consumption per person in SAP

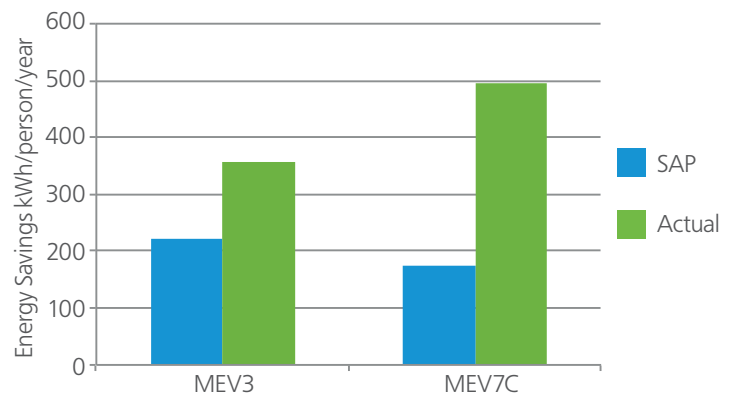
Figure 24: Savings from waste water heat recovery per person

As part of the project the in-use performance of waste water heat recovery units were measured, but due to monitoring equipment failures, only two full sets of results were collected (see Figure 24).

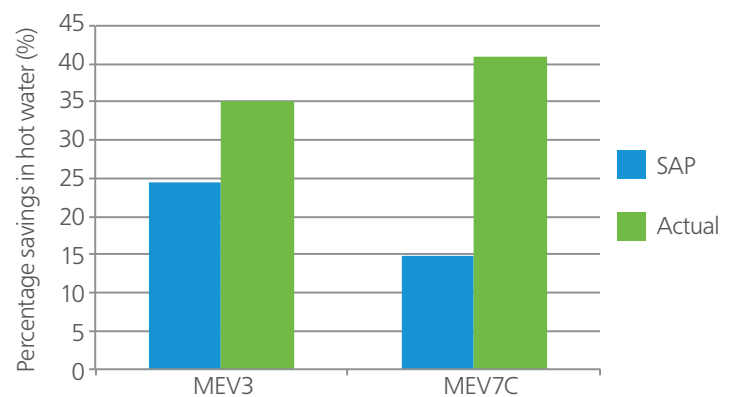
This shows that for home MEV3, 25% savings were calculated, but 35% were obtained and for home MEV7C, 15% were calculated and 41% were obtained.

Figure 25: Percentage saving shown in SAP and actual for WWHR

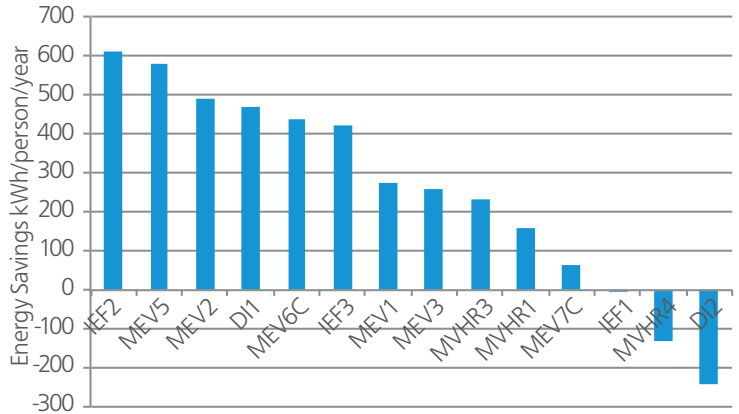
Figure 26: Water heating energy savings per person over those shown in SAP

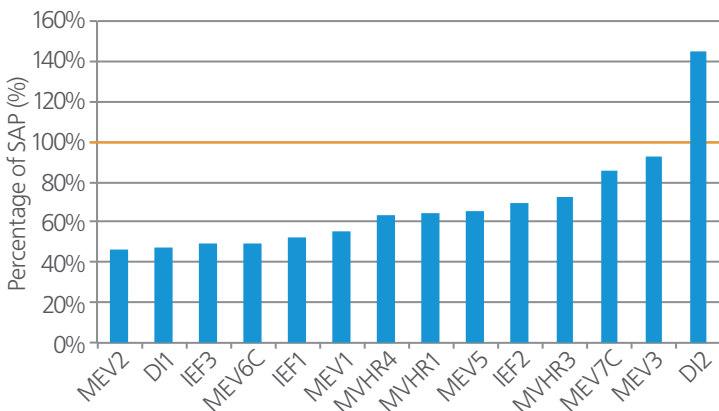
Figure 27: Regulated Electricity use as compared to SAP

SAP shows electricity use for ventilation fans, the heating pump, the boiler fan and lighting. Lighting and ventilation fans can be directly measured. The heating circuit can be measured and this can be used as a proxy for the heating pump plus the boiler fan.

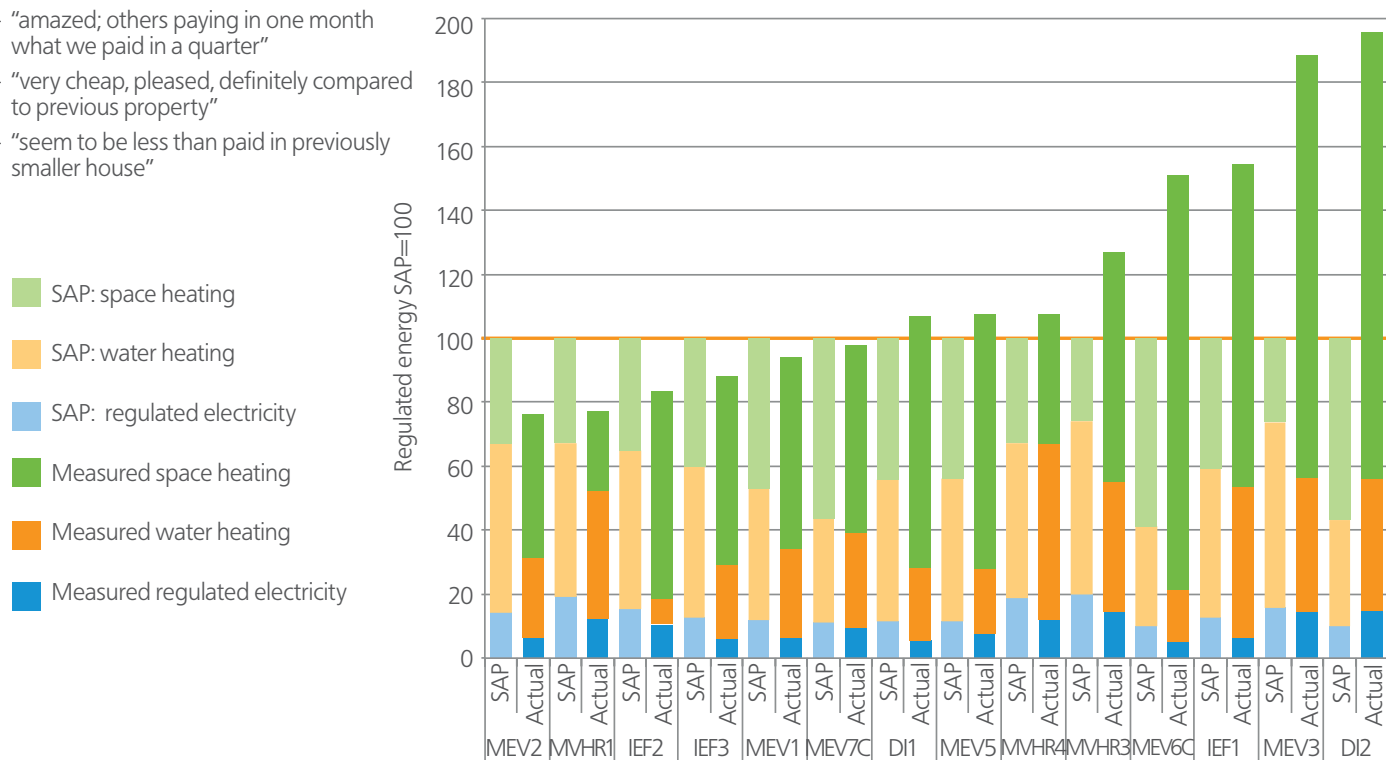
Figure 28: Measured Regulated Energy Use (water heating normalised for occupancy levels) and Predicted SAP energy use (SAP=100)
